Postoperative CBCT imaging in case of a complication after MR imaging

CASE STUDY

This case study describes two postoperative cases with cochlear implantation that showed complications in the processor part of the implant after undergoing magnetic resonance imaging (MRI) of other parts of the body.

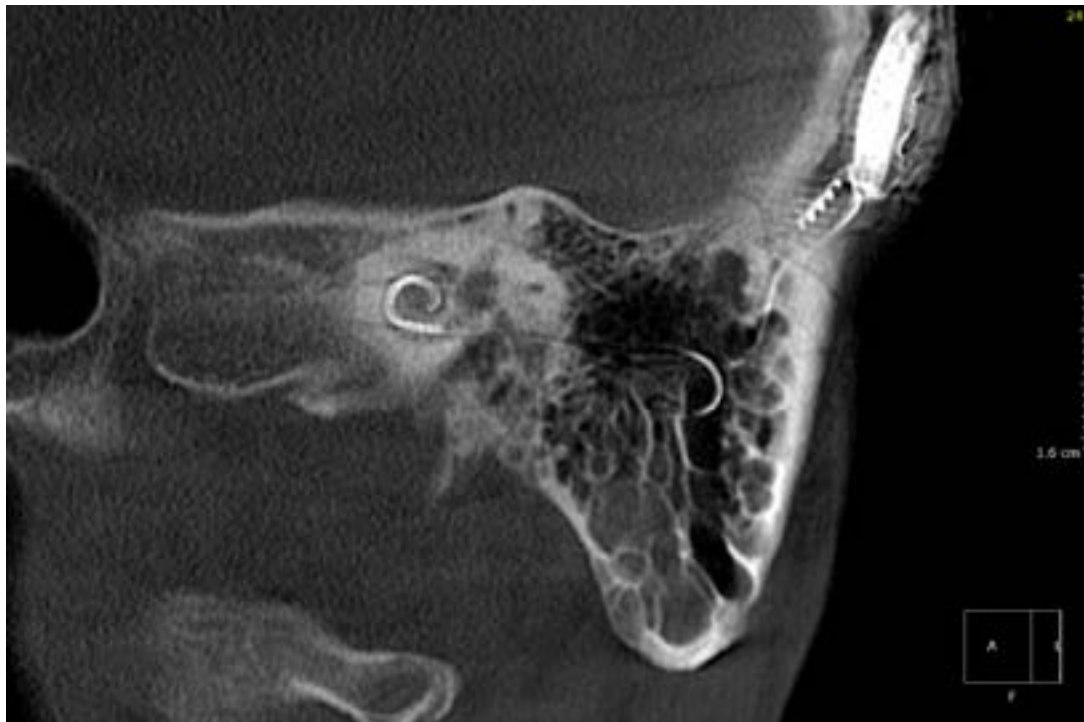
Fig. 1 Patient #1: Sagittal oblique reformatted CBCT image showing the intracochlear portion of the implant.

On CBCT all the four important parts of the implant were very well seen both on the axial slices and three dimensional surface reconstruction images. The implant is placed on magnetic plates, and the extracochlear part was seen in abnormal separated position. The intracochlear electrode array showed no signs of separation in neither of the cases. The intracochlear electrodes were well seen in both of the cases.

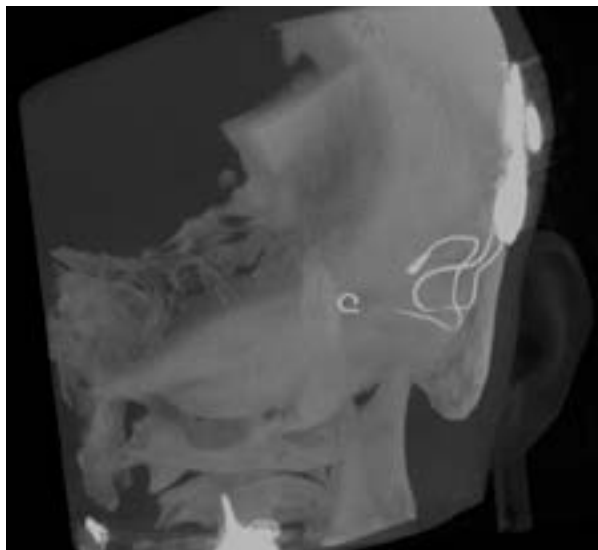
Fig. 2 3D MIP image of patient #1.

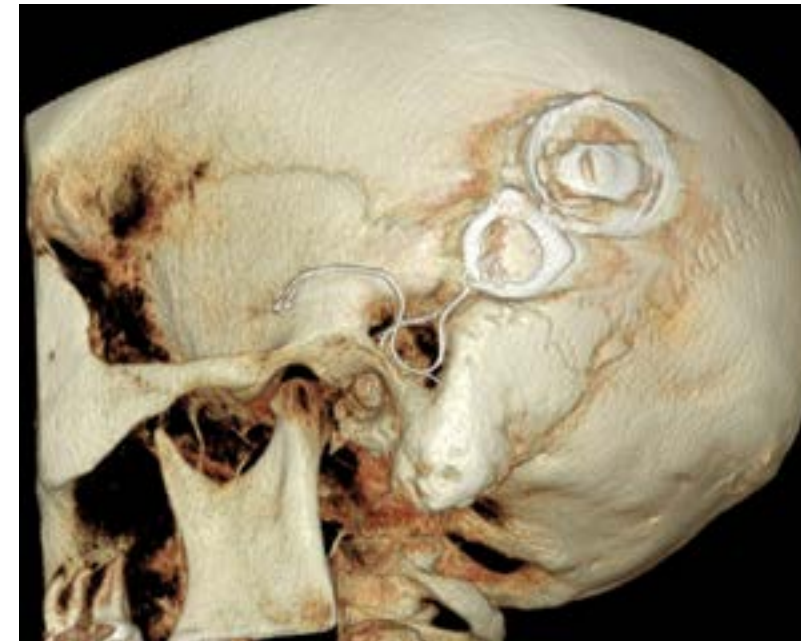
Fig. 3 3D reconstruction image of patient #1.

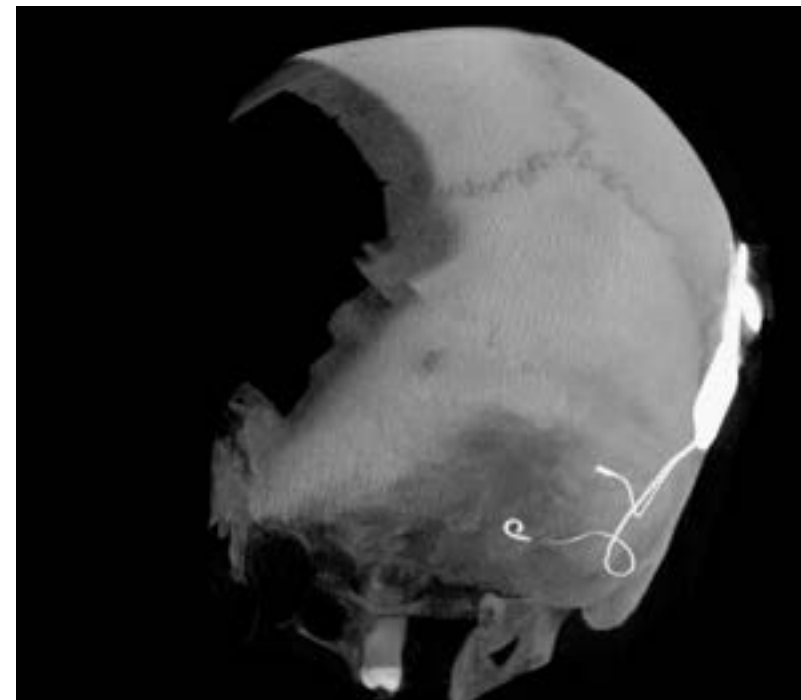
Fig. 4 3D MIP image of patient #2.

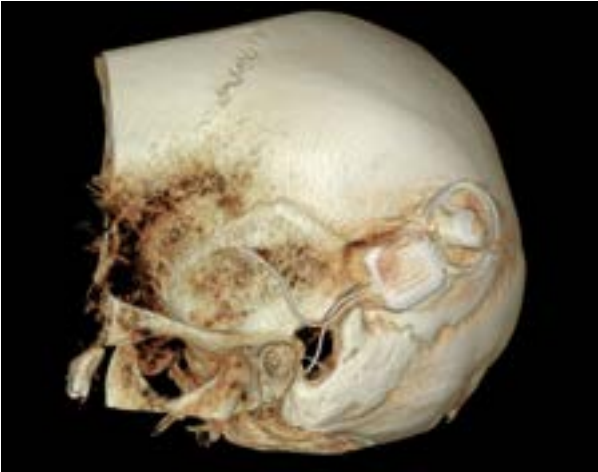
Fig. 5 3D reconstruction image of patient #2.

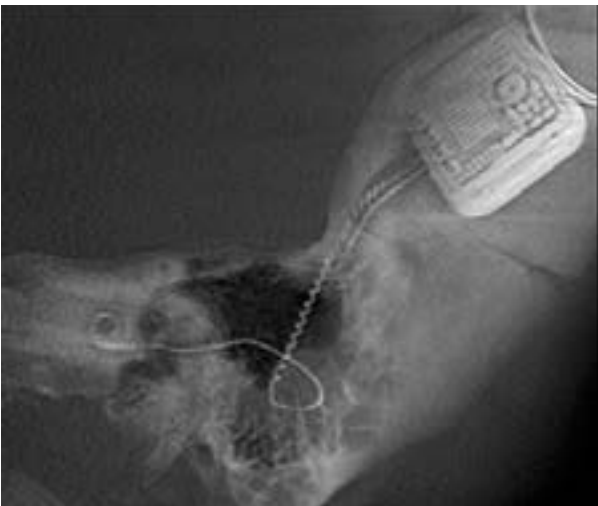
Fig. 6 Sagittal thick MIP image of the implant of patient #2.

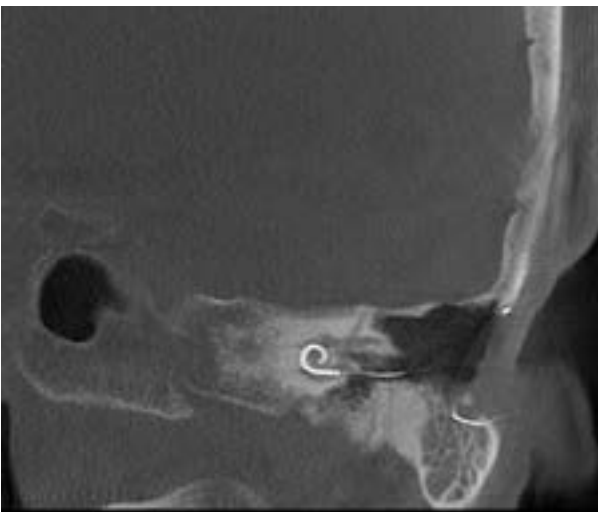
Fig. 7 Patient #2: sagittal oblique image of the intracochlear portion of the implant.
